# The Runner is running once again

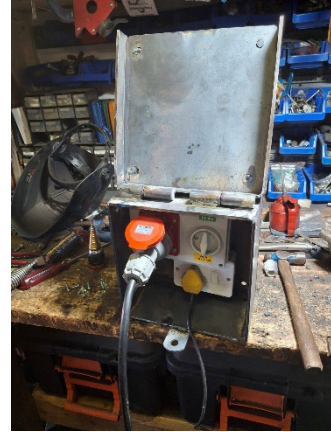
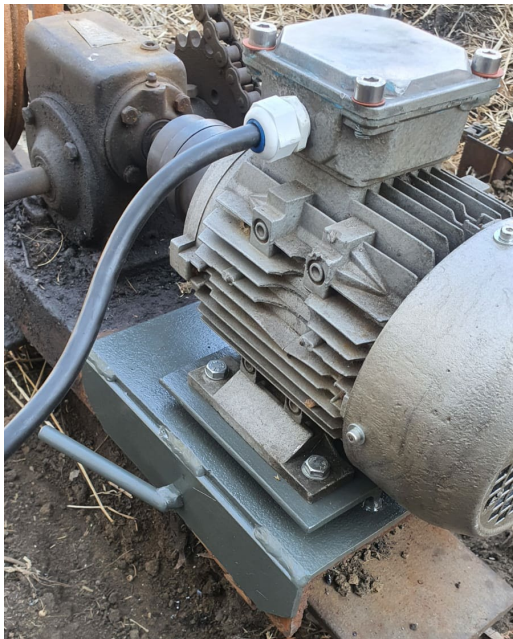
We also decided to make the motor removable to protect it from theft, after all it too has a lock of copper in. Pieter Fourie offered to remake the motor mount to allow it to be easily removed and locked away.

The mount is designed such that you place it on the rail, place the coupling rubber (spider) into the coupling and slide the motor into the coupling and then insert the “wing-nuts” (single arm) and tighten the motor in place.

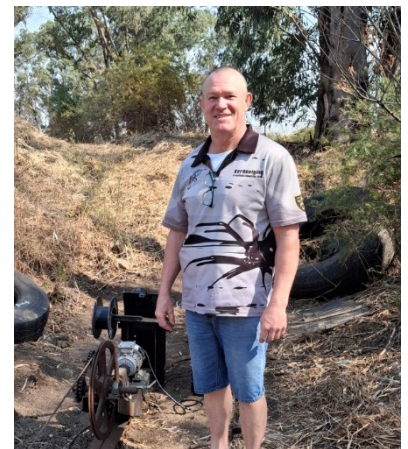
The whole motor control system had to be rebuilt from scratch but it must be built such that it can be unplugged and stored safely in the clubhouse or containers.

Now the control box plugs into the main 3-phase supply socket, which includes a mechanical interlock which prevents the plug from being energised without the plug properly inserted into the socket and the plug also may not be removed until the socket is switched to the off position. The motor also plugs into the motor control box. The new plug box and cable are embedded in a good deal of concrete to make theft more difficult, and we have assigned angles to stand guard.

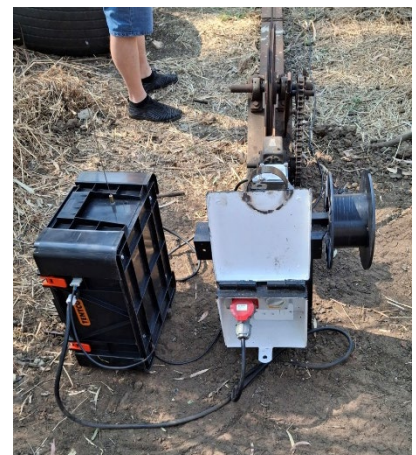
Clive and I commissioned the system on Thursday; we experience a few minor issues mainly with loos/bad connections in the control circuitry, but within a few minutes we had the runner moving back and forth.
